Combined Advanced Finishing and UV-Laser Conditioning for Producing UV-Damage-Resistant Fused Silica Optics

Joseph A. Menapace^a, Bernie Penetrante^a, Don Golini^b, Al Slomba^c,
Phil E. Miller^a, Tom Parham^a, Mike Nichols^a, and John Peterson^a

ABSTRACT

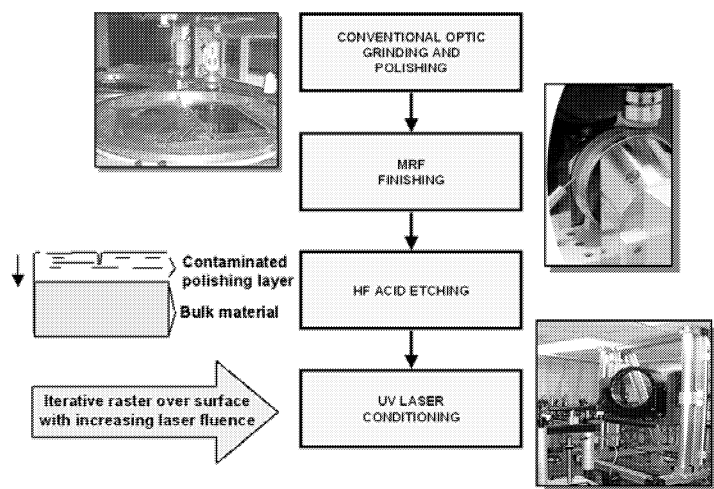
Figure 1: Combined advanced finishing recipe to improve UV damage resistance of fused silica optics.

provides a means of fabricating UV damage resistant optical components with minimal changes in the manufacturing process as shown in Figure 1.

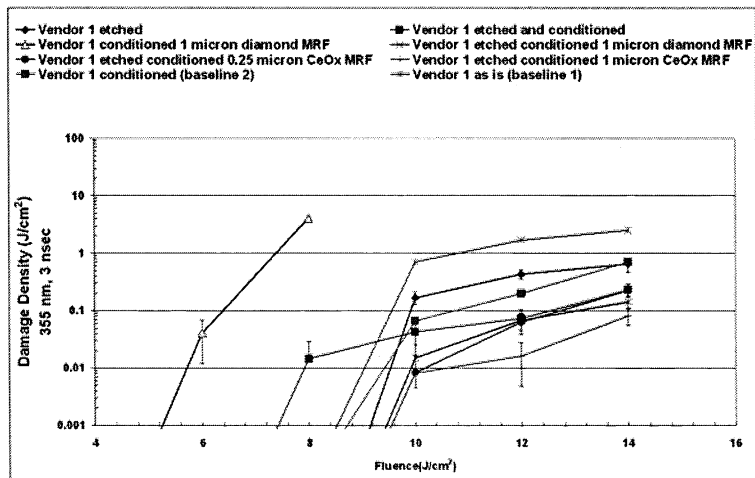
Figure 5: Damage density observed at 355 nm, 3 nsec, on 14.3-cm x 14.3-cm x 2.5-cm fused silica optic cut from full size NIF flat optic polished by Vendor 1.

The results of large area damage testing conducted on each of the specimens are listed in Table 3 and plotted in Figure 5. Etching 1 μm from the surfaces of the Vendor 1 supplied optic results in about a factor of 4 improvement in the damage

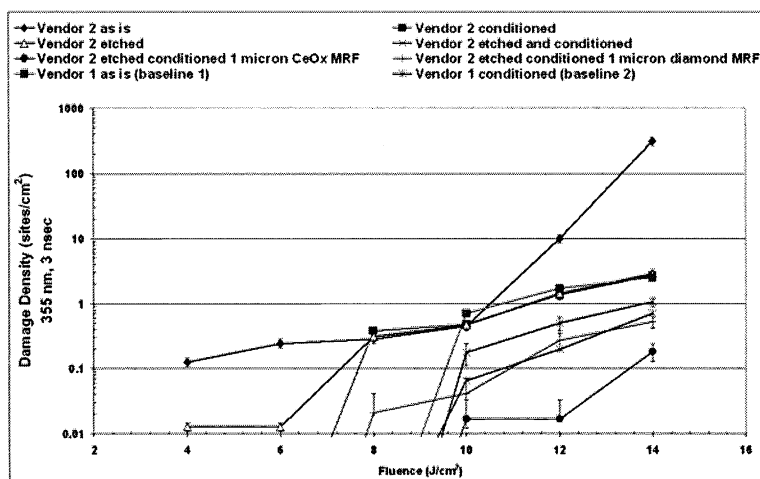
Figure 6: Damage density observed at 355 nm, 3 nsec, on 14.3-cm x 14.3-cm x 1.0-cm fused silica optic cut from full size NIF high aspect ratio optic polished by Vendor 2.

Application of MRF final polishing and 3ω post processing techniques to subsections cut from the fused silica flat provided by Vendor 2 are meant to illustrate that improvements in damage performance can be made on optics that are unacceptable for high fluence ultraviolet laser applications. These represent optics for which little to no attention was paid to the type of polishing slurry used nor to the extent of subsurface damage encountered during the fabrication process. The results of large aperture damage testing on the subsections are presented in Table 4 and Figure 6.

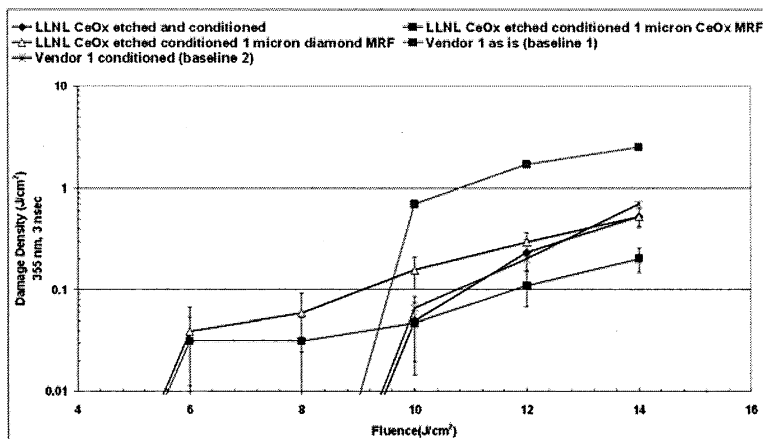
Figure 7: Damage density observed after illumination by 1 shot/site at 355 nm with no correction for beam shape. Fluences are scaled to equivalent values at 3-nsec.

Additional CeOx lap polishing of subsections cut from the Vendor 2 supplied conventionally finished optics is intended to test the possibility of improving performance through careful removal of fused silica from the optical surfaces prior to MRF final polishing. The goal in these experiments is to remove material under small normal loads to remove or minimize the subsurface damage layer present from prior fabrication steps. A further assumption is that additional lapping of 25 μm from the optical surfaces is sufficient to eliminate these effects. The results of large aperture damage testing on the subsections are presented in Table 5 and Figure 7.
