Combined Advanced Finishing and UV-Laser Conditioning for Producing UV-Damage-Resistant Fused Silica Optics

Joseph A. Menapace^a, Bernie Penetrante^a, Don Golini^b, Al Slomba^c,
Phil E. Miller^a, Tom Parham^a, Mike Nichols^a, and John Peterson^a

^a Lawrence Livermore National Laboratory,
7000 East Avenue Livermore CA, 94550-9234

ABSTRACT

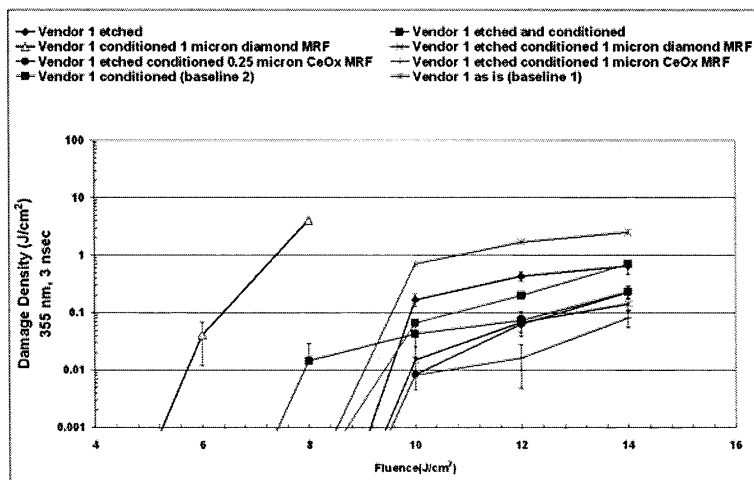
Figure 5: Damage density observed at 355 nm, 3 nsec, on 14.3-cm x 14.3-cm x 2.5-cm fused silica optic cut from full size NIF flat optic polished by Vendor 1.

The results of large area damage testing conducted on each of the specimens are listed in Table 3 and plotted in Figure 5. Etching 1 μm from the surfaces of the Vendor 1 supplied optic results in about a factor of 4 improvement in the damage

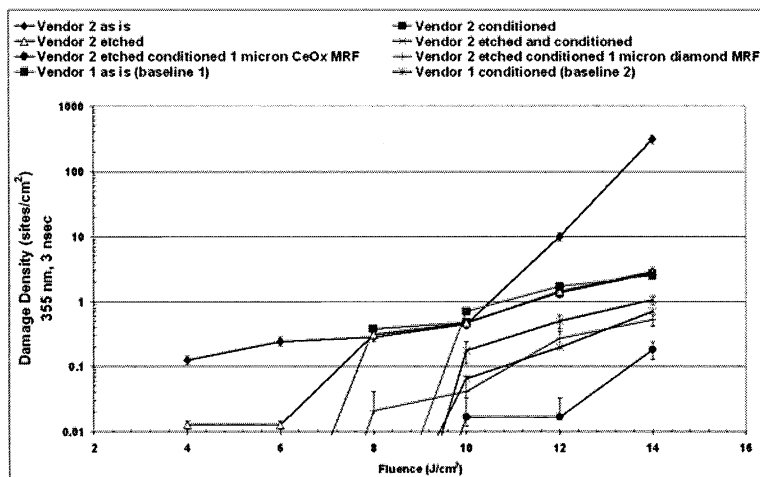
Figure 6: Damage density observed at 355 nm, 3 nsec, on 14.3-cm x 14.3-cm x 1.0-cm fused silica optic cut from full size NIF high aspect ratio optic polished by Vendor 2.

Application of MRF final polishing and 3ω post processing techniques to subsections cut from the fused silica flat provided by Vendor 2 are meant to illustrate that improvements in damage performance can be made on optics that are unacceptable for high fluence ultraviolet laser applications. These represent optics for which little to no attention was paid to the type of polishing slurry used nor to the extent of subsurface damage encountered during the fabrication process. The results of large aperture damage testing on the subsections are presented in Table 4 and Figure 6.
